**WALNUT HOLLOW LAKE DAM
IRON COUNTY, MISSOURI
MO 30619**

**PHASE 1 INSPECTION REPORT
NATIONAL DAM SAFETY INSPECTION**

**Phase I Inspection Report
National Dam Safety Program**

Name of Dam	Walnut Hollow Lake Dam
State Located	Missouri
County Located	Iron
Stream	Unnamed Tributary of Big Creek
Date of Inspection	11 November 1980

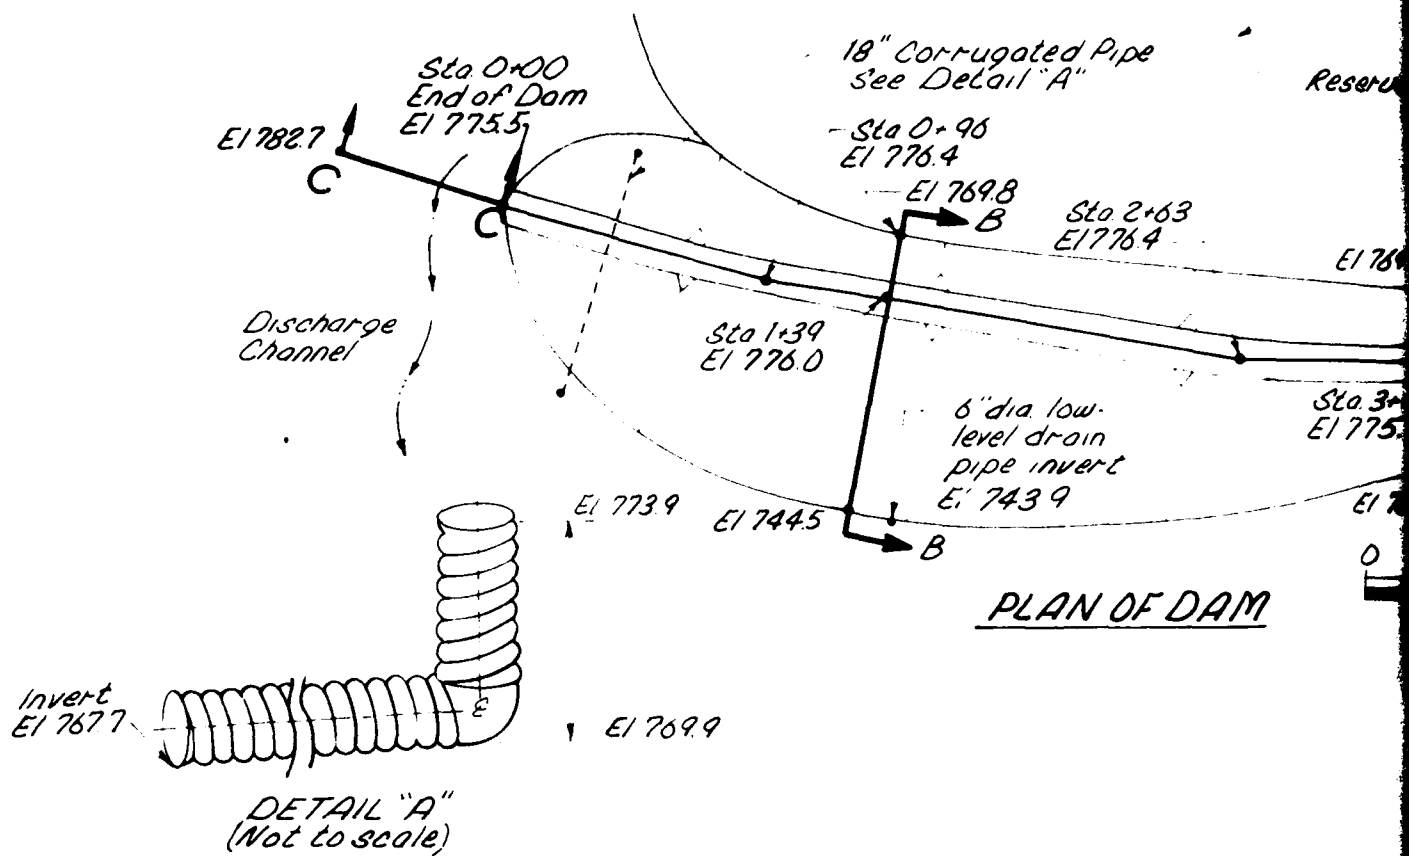
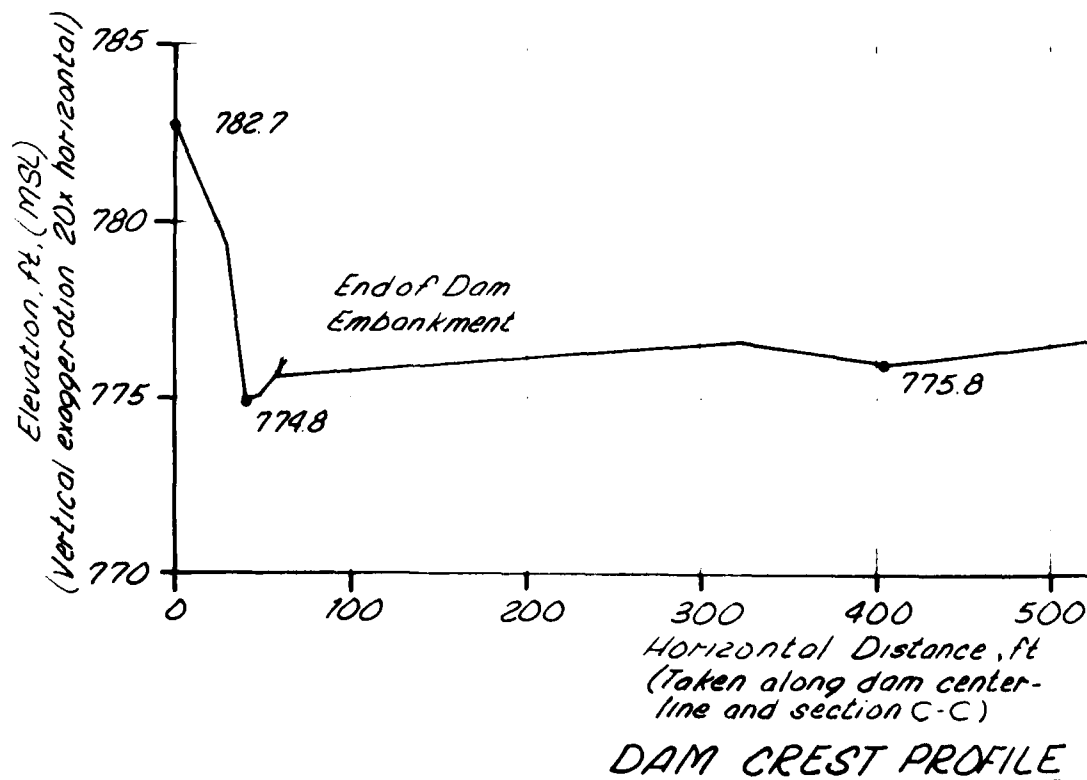
Fig. 3-A

- a. Description of dam and appurtenances. Walnut Hollow Lake Dam is an earth dam impounding a lake used for recreational purposes. The dam was constructed in an arc, convex in a downstream direction, and crosses two small drainages separated by a small hill. The result is a rise in the elevation of the base of the dam near the center of the embankment (Fig 3-A; and Fig A-1, Appendix A).

- Mr Glick reported the dam was keyed to bedrock, the trench being about one dozer blade wide. The reservoir area covers two small drainages formerly separated by a small hill. The hill within the area of the present reservoir was used as borrow to construct the dam embankment. A portion of the hill projects through the dam alignment, partially separating the dam embankment into two halves (Fig 3-A; and Fig A-1, Appendix A).

- c. **Appurtenant structures.** The main spillway consists of an uncontrolled, 18-in. diameter corrugated galvanized pipe; the configuration is shown in Fig 3-A. The inlet is not protected by a trash rack (Photo 4) and the outlet discharges near the toe of the embankment into a wooded area (Photo 5). There is some evidence of limited prior flow through the main spillway. Both inlet and outlet are located near the right abutment.
